A Reconnaissance Natural Hazard Assessment of Lakes Lyndon, Coleridge and Tekapo

A thesis
submitted in partial fulfilment
of the requirements for the degree
of
Master of Science in Hazard and Disaster Management
at the
University of Canterbury
by
Anita Louise Komen

University of Canterbury
2008

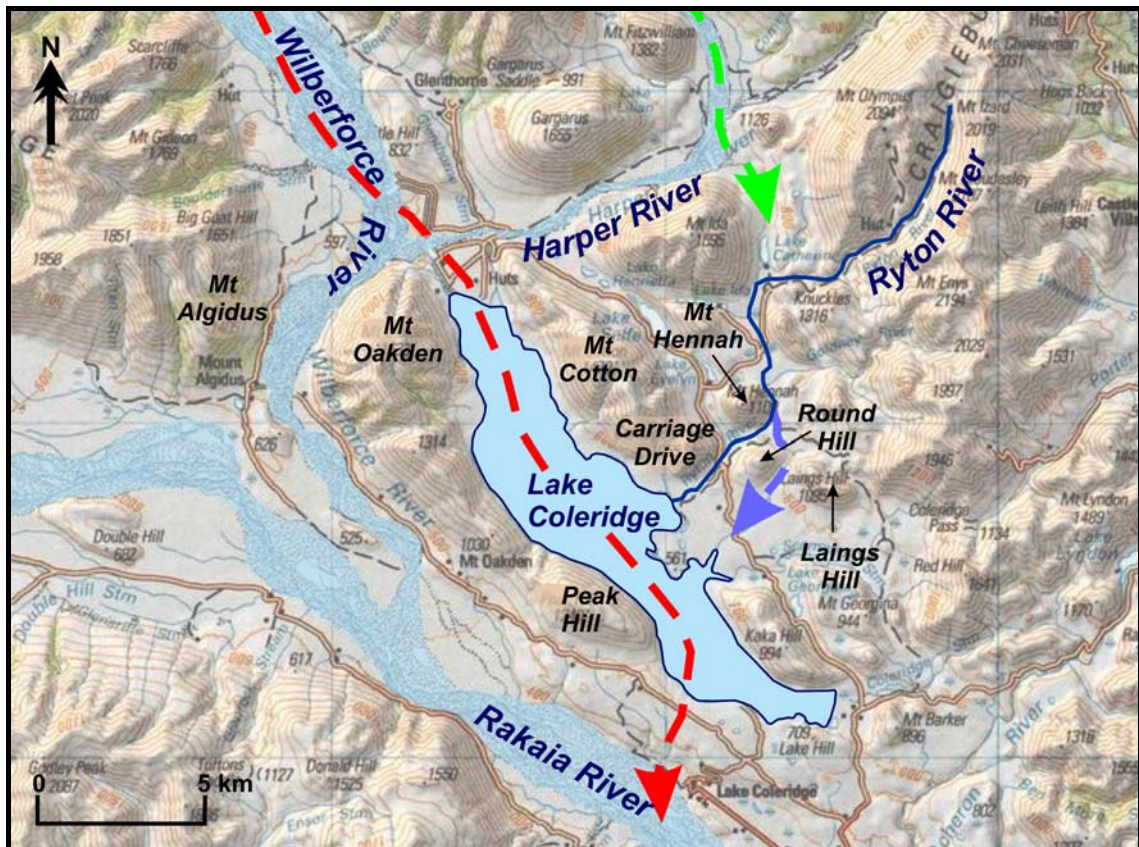
Figure 2.7: Present day and pre-glacial courses of the major rivers around Lake Coleridge. The Wilberforce River is thought to have once followed the route indicated by the red arrow and the Harper River is once thought to have flowed east of Lake Coleridge in a valley indicated by the green arrow. The Rytton River is thought to have flowed down the path indicated by the blue arrow before deglaciation.

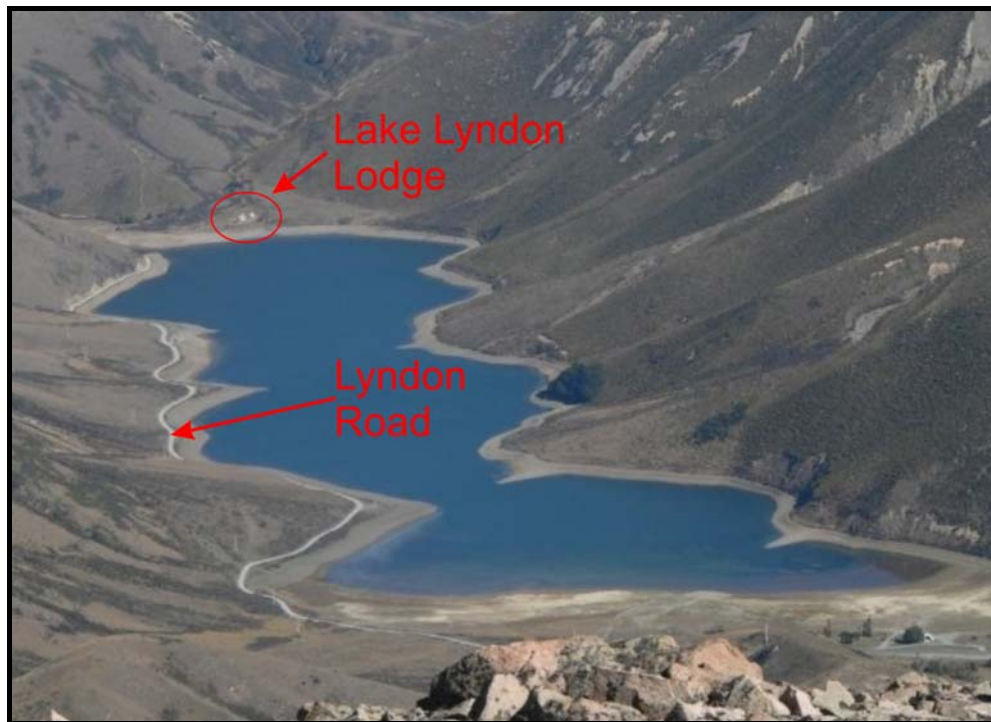
Figure 5.7: The location of Lyndon Road and Lake Lyndon Lodge at Lake Lyndon.

Lyndon Road and Lake Lyndon Lodge are at risk from direct landslide impact and also from the impact of a landslide induced wave (Figure 5.7). The size of a possible wave has not been constrained but given that the road and lodge are within only a few metres elevation of the lake water level and are very close to the lake edge, it would not take a very large wave to cause damage. Slides into shallow water are generally more critical than those that occur in deep water because more extreme wave heights can be generated (Masson *et al.*, 2006).

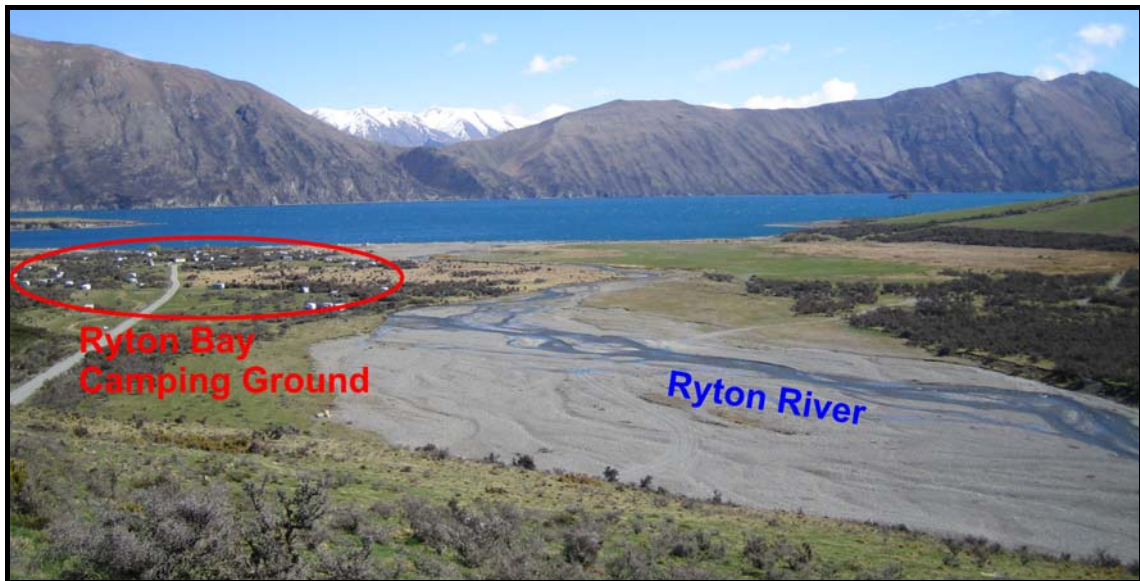
Figure 5.10: The lower reaches of the Ryton River. The Ryton Bay Camping Ground is situated on the flood plain of this river.

Landslides also have the ability to block or dam a river, causing water upstream to pond and form a lake. Such lakes are huge threats to downstream development as they seldom last long. The area of greatest concern from a landslide dam forming is along the Ryton River. At least two past rock avalanches are known to have blocked the Ryton River and these are the Lake Coleridge Rock Avalanches 1 and 2 (refer to section 5.3.1). The largest of these lakes is thought to have had a volume of c. $17 \times 10^6 \text{m}^3$ (Lee, 2004), which upon sudden failure would have most probably flooded the lower reaches of the Ryton River where a camping ground exists today (Figure 5.10) .

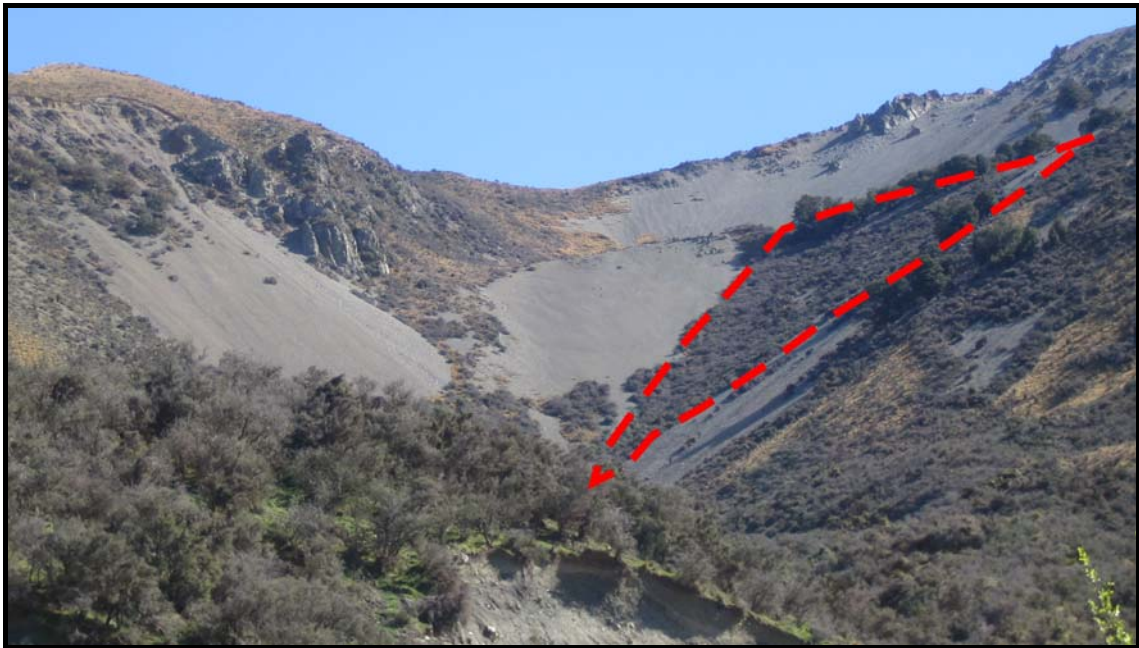
Figure 5.11: The Lake Coleridge Rock Avalanche source area on the south-eastern side of Carriage Drive. The wedge block of displaced material, identified by Lee,(2004), is outlined in red.

The likelihood of a future rock avalanche from Carriage Drive is very high. It is evident that large volumes of material are present in the source area, which could feed a number of future events. A wedge block of displaced material was identified by Lee (2004) and is considered to be the likely source material for a future rock avalanche (Figure 5.11).

This block, which is estimated to be c. $35,000 \pm 5000 \text{ m}^3$ in volume, has the potential to once again dam the Ryton River. The top of the source area consists of sub-vertical Torlesse beds along which dilation is occurring (ibid). Therefore, future dilation of the rock mass, earthquakes or storm events could trigger a future landslide. The threat of a landslide damming the Ryton River not only comes from Carriage Drive but from other slopes next to the river, such as from Round Hill and Mount Hennah.

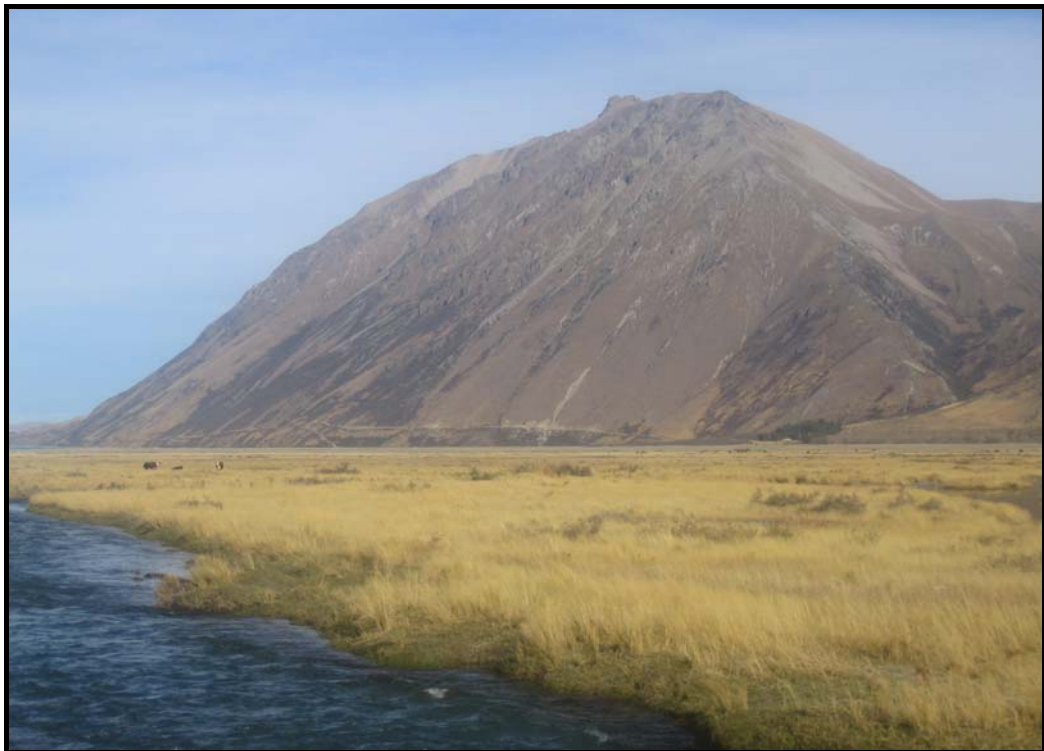
Figure 5.16: Mistake Peak is situated on the north-western shores of Lake Tekapo. The Godley River, which drains into the northern side of the lake, is shown in the foreground.

The slopes to the north-west of Lake Tekapo are extremely steep (Figure 5.16). These slopes are subject to periodic rockfalls and if a large section were to collapse, large waves could be generated, flooding low-level areas, such as low-lying areas of

Richmond Station (within 10 m elevation of the lake level). Other low-level areas to the north and east of Lake Tekapo could also be at risk from flooding as a result of a landslide dam blocking either the Godley or Macaulay Rivers. The slopes on either side of these rivers are extremely steep right along their entire length. Even partial blockage of one of these rivers could divert the river flow enough so that low-level areas with development could be flooded.
